## Perceptible Investigation of Established Building to Endorse Repair Approaches

The present study aims to evaluate the structural and durability condition of the established building constructed in 2008 at Geethanjali Institution of Science and Technology, Nellore, through a systematic perceptible (visual and preliminary technical) investigation. The specific objectives are:

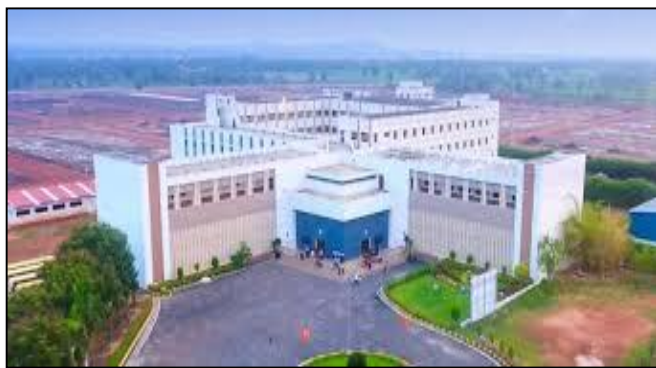
**Figure 1 Institutional Building and Plan**

The building has an approximate frontage of 80–90 m and a depth of about 25–30 m, forming a symmetrical academic block with a central administrative core and two extended wings. Each classroom (60 seating capacity) is assumed to measure roughly 8 m × 7 m (56 m<sup>2</sup>). The two digital halls (240 capacity each) are approximately 18 m × 14 m (250 m<sup>2</sup>), while the 700-capacity seminar hall may occupy around 30 m × 20 m (600 m<sup>2</sup>). The library (250 capacity) is estimated at 20 m × 15 m (300 m<sup>2</sup>). Laboratories are approximately 12 m × 8 m (96 m<sup>2</sup>) each. Administrative rooms (HOD, Principal, Director, etc.) may range from 12–25 m<sup>2</sup> depending on function. These dimensions are rough estimates for planning and documentation purposes only.

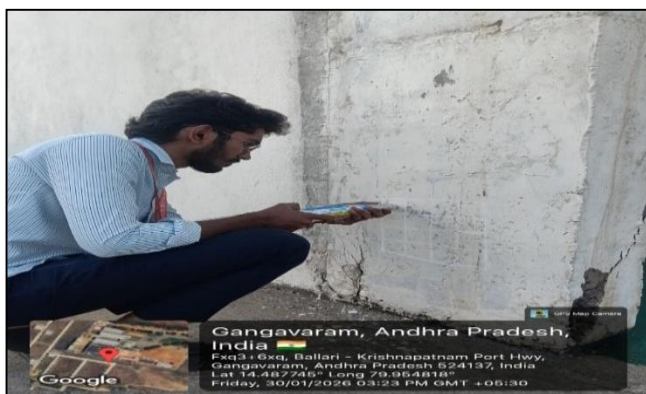
**Figure 3** Rebound Hammer Test

The Rebound Hammer test (Schmidt Hammer) was conducted to evaluate the in-situ surface hardness and estimate the approximate compressive strength of concrete. As shown as Figure 3.

Test locations were carefully selected in both sound and visibly distressed areas to enable comparative assessment of concrete quality. Prior to testing, the surface was cleaned and made smooth to ensure reliable readings. At each test point, multiple impacts

were applied, and the corresponding rebound numbers were recorded. The average rebound value for each location was calculated to minimize the influence of surface irregularities and random errors. These average values were then correlated with standard calibration charts to estimate the equivalent compressive strength of concrete. The results helped identify potential zones of weakened or deteriorated concrete and provided a rapid, non-destructive means of assessing structural condition and uniformity.

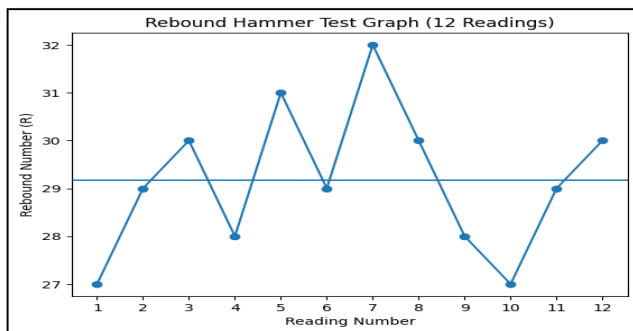
Figure 5 Rebound Hammer Test Graph

The rebound hammer test was conducted on a concrete wall surface using an N-type Schmidt hammer. Twelve readings were recorded, giving an average rebound number of 29.2. Based on standard calibration charts, the estimated compressive strength of concrete is approximately 22 MPa. The quality of concrete is assessed as fair to good.[7]
